LEAN SIX SIGMA GREEN BELT PROJEKAT

*Decreasing number of pinning mistakes
on Daimler NGA IP line*

Vođa projekta: Branislav Žujović

21.03.2023.

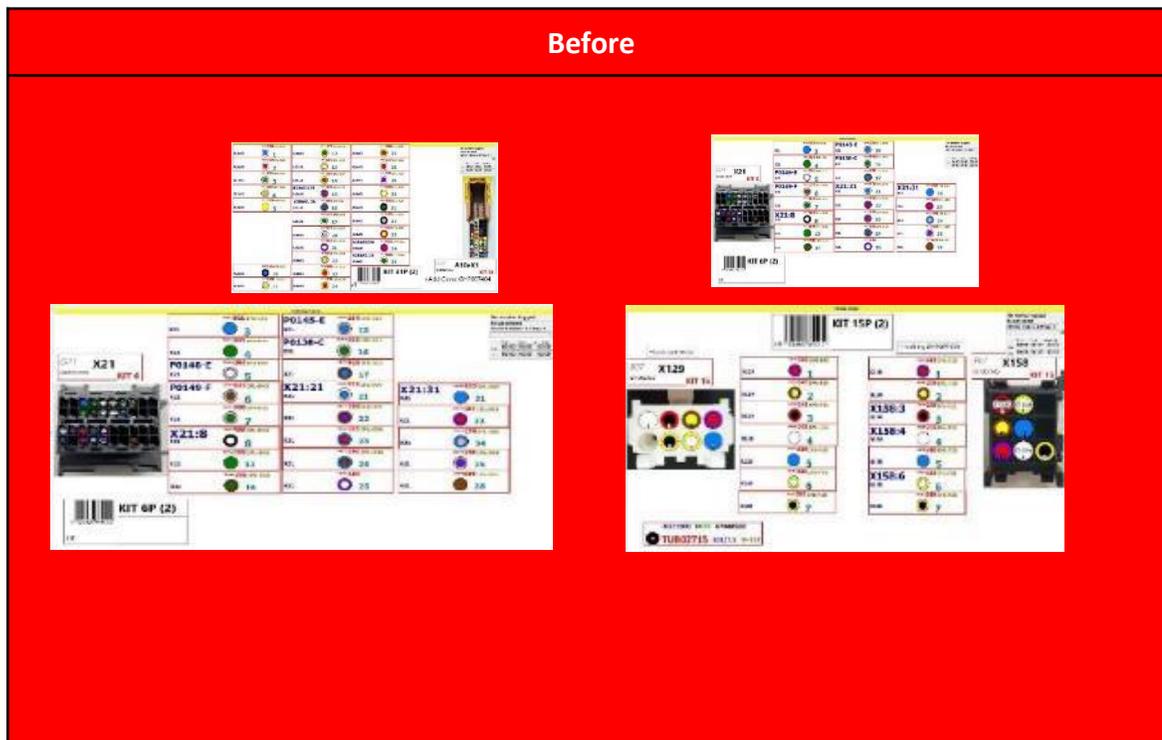
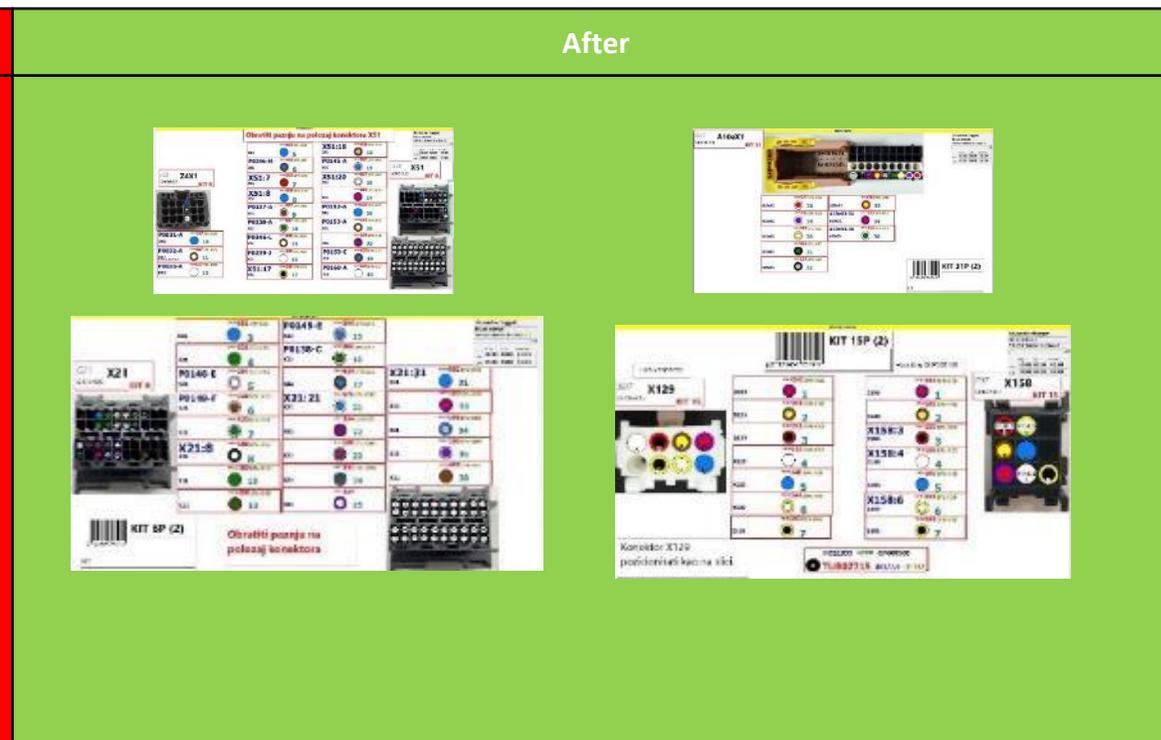
LAD instruction improvement

Root causes : Unclear visualization of pins in LAD for connectors X21,X51,X53

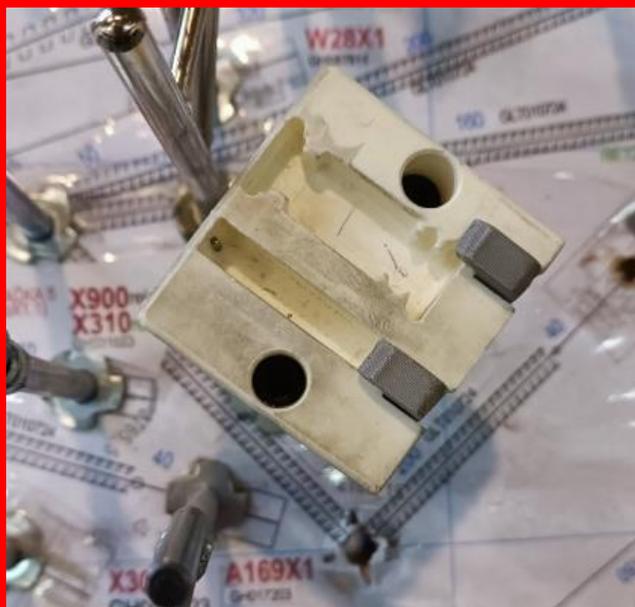
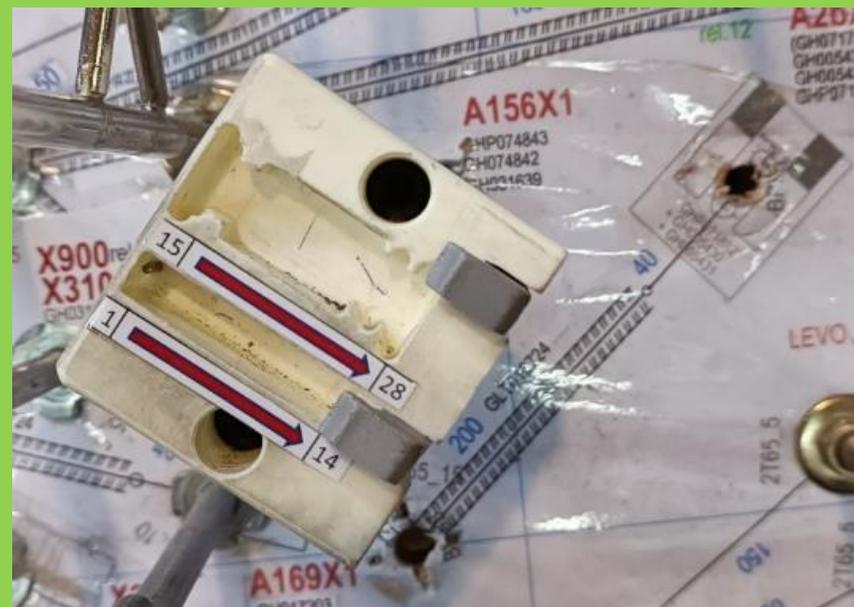
Assembly board pin visualization on contra parts

Root cause : Not enough visualization on assembly board for A156x1, X117 and Z1X1 (pins)

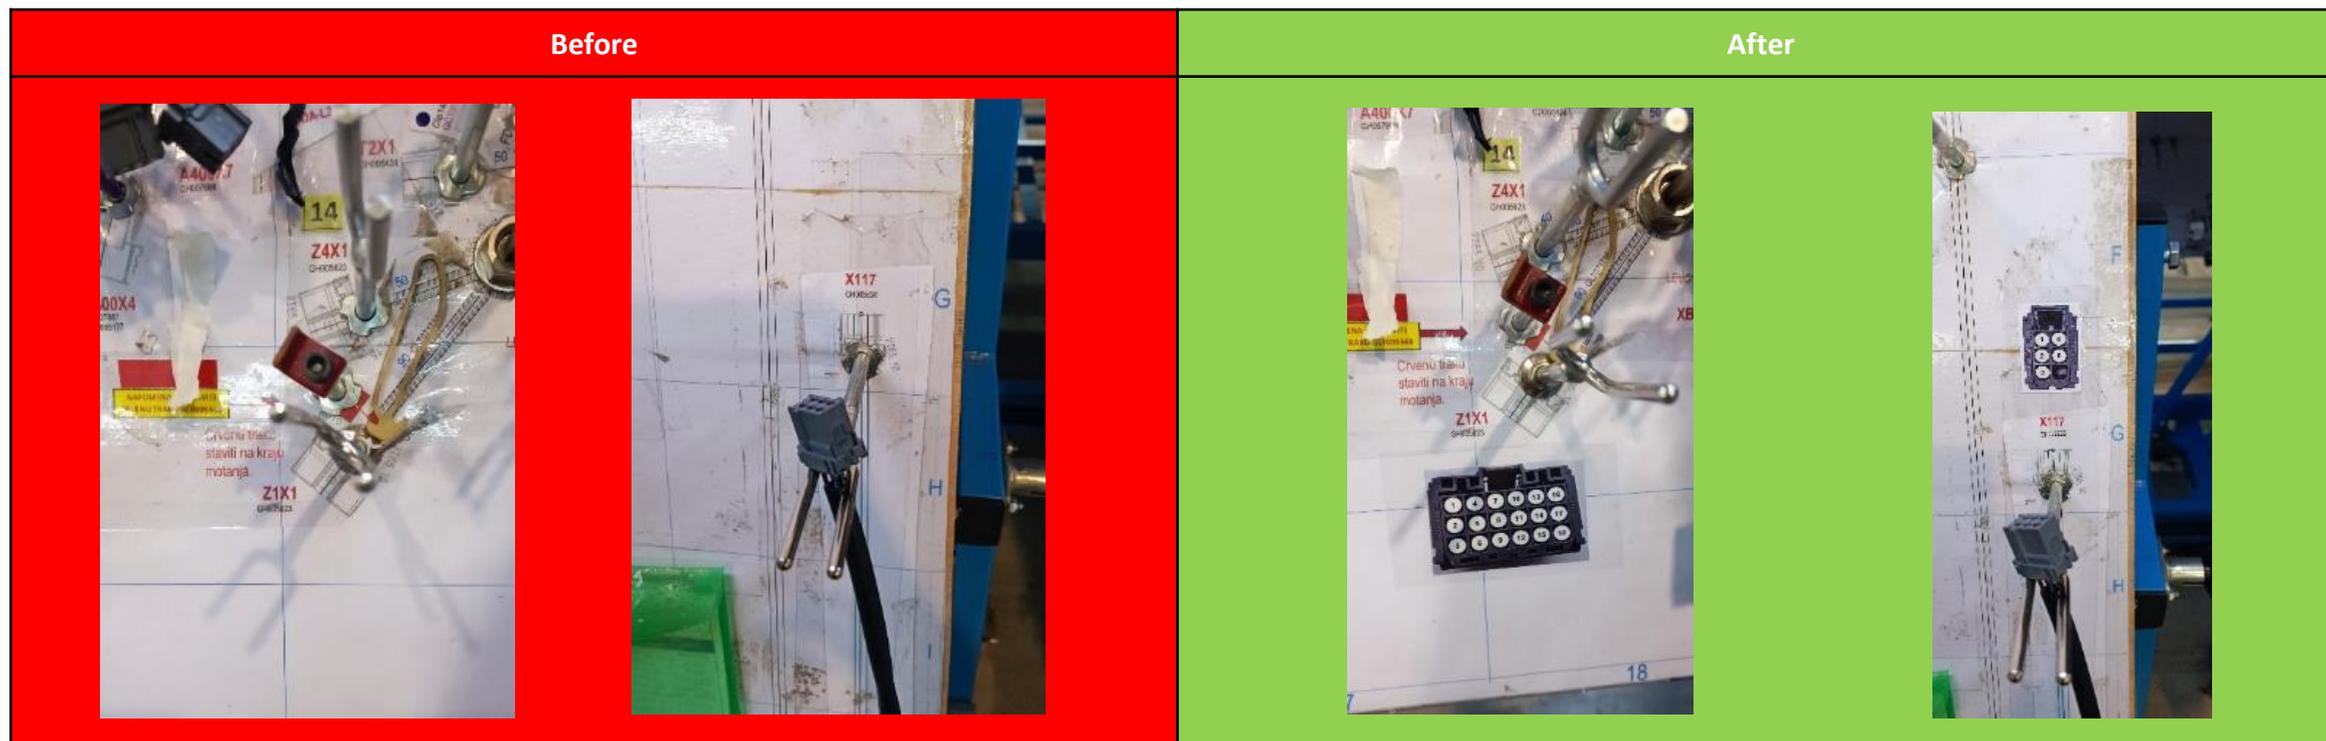
Assembly board pin visualization on contra parts for connectors X117 i Z1X1

Root cause: Not enough visualization on assembly board for A156x1, X117 and Z1X1 (pins)

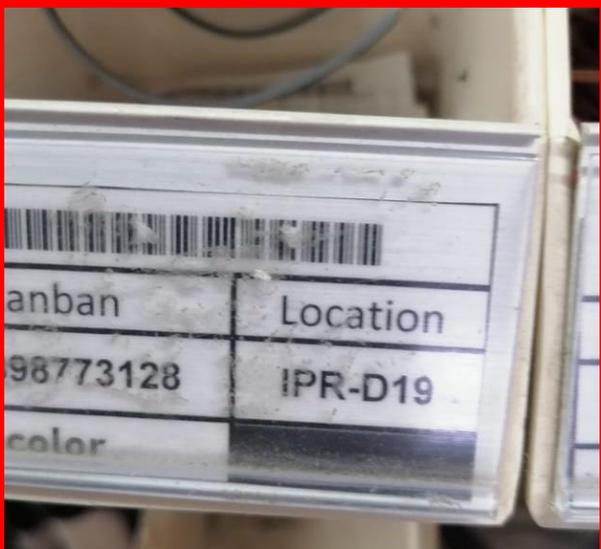
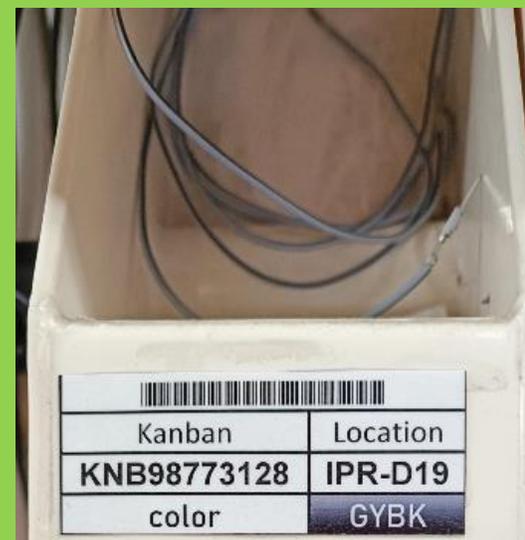
Visualization of labels on wires rack

Root cause: Unclear marking of wires racks

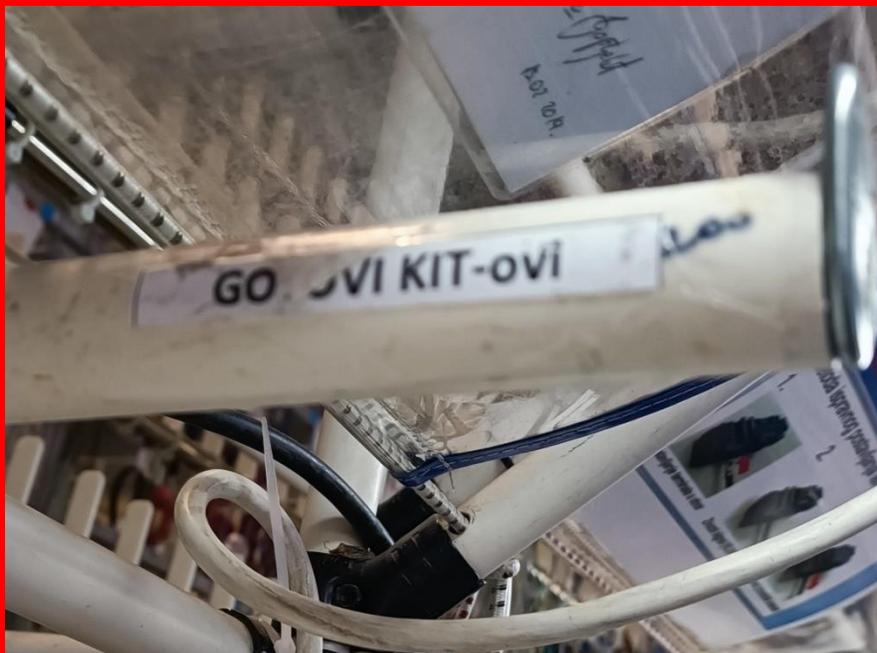
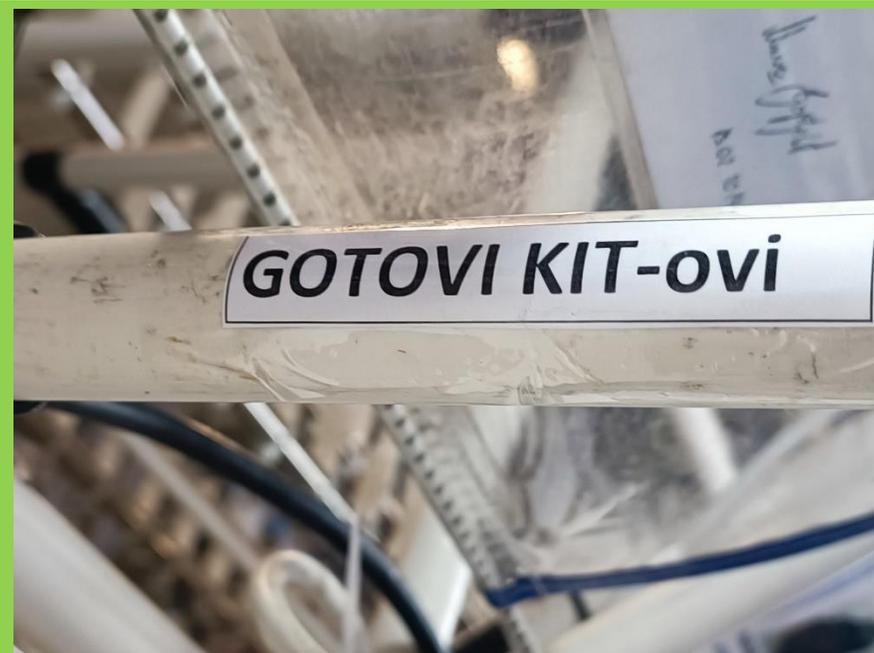
Visualization of hooks for KITs

Root cause: Unclear marking of wires racks

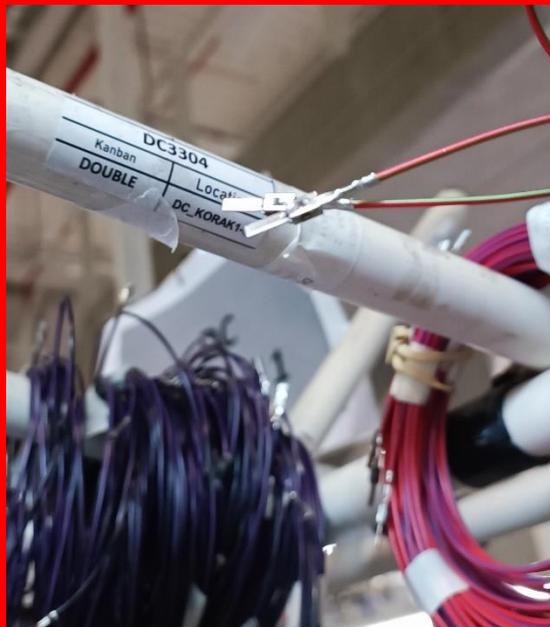
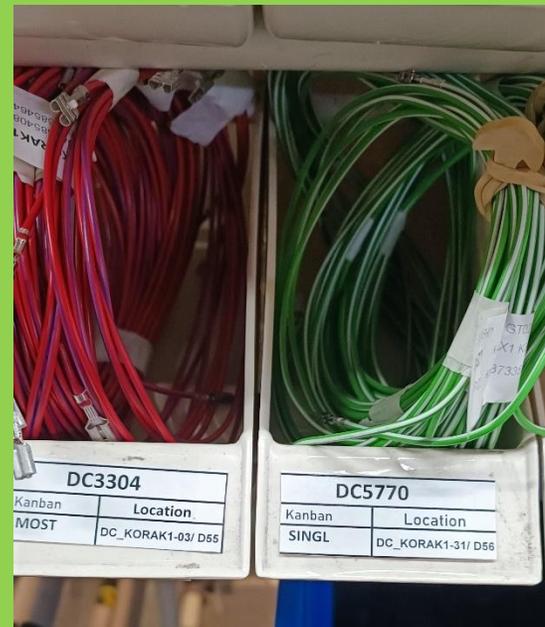
Rearrange of double crimp wires position on step1

Overload work on preassembly stations 1 and 4

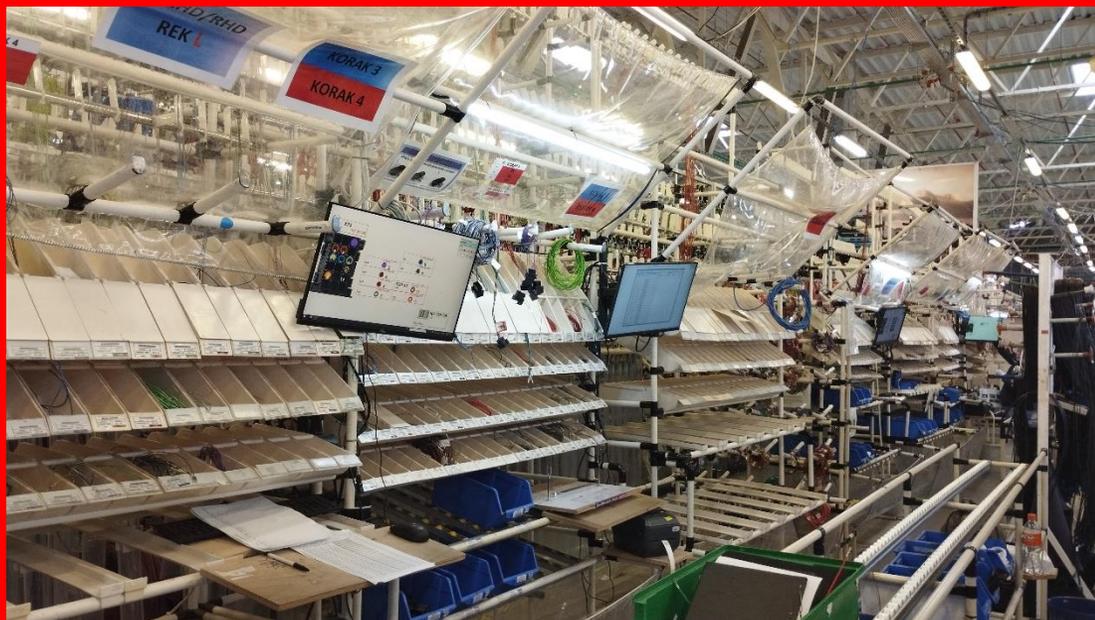
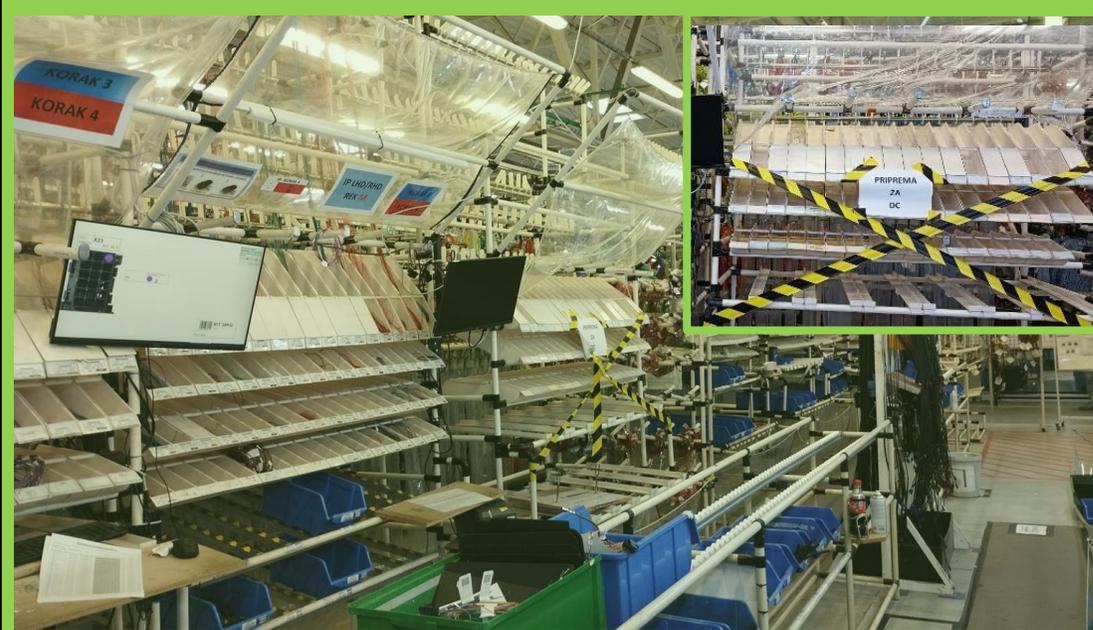
Rearrange of double crimp wires position on step4

Overload work on preassembly stations 1 and 4

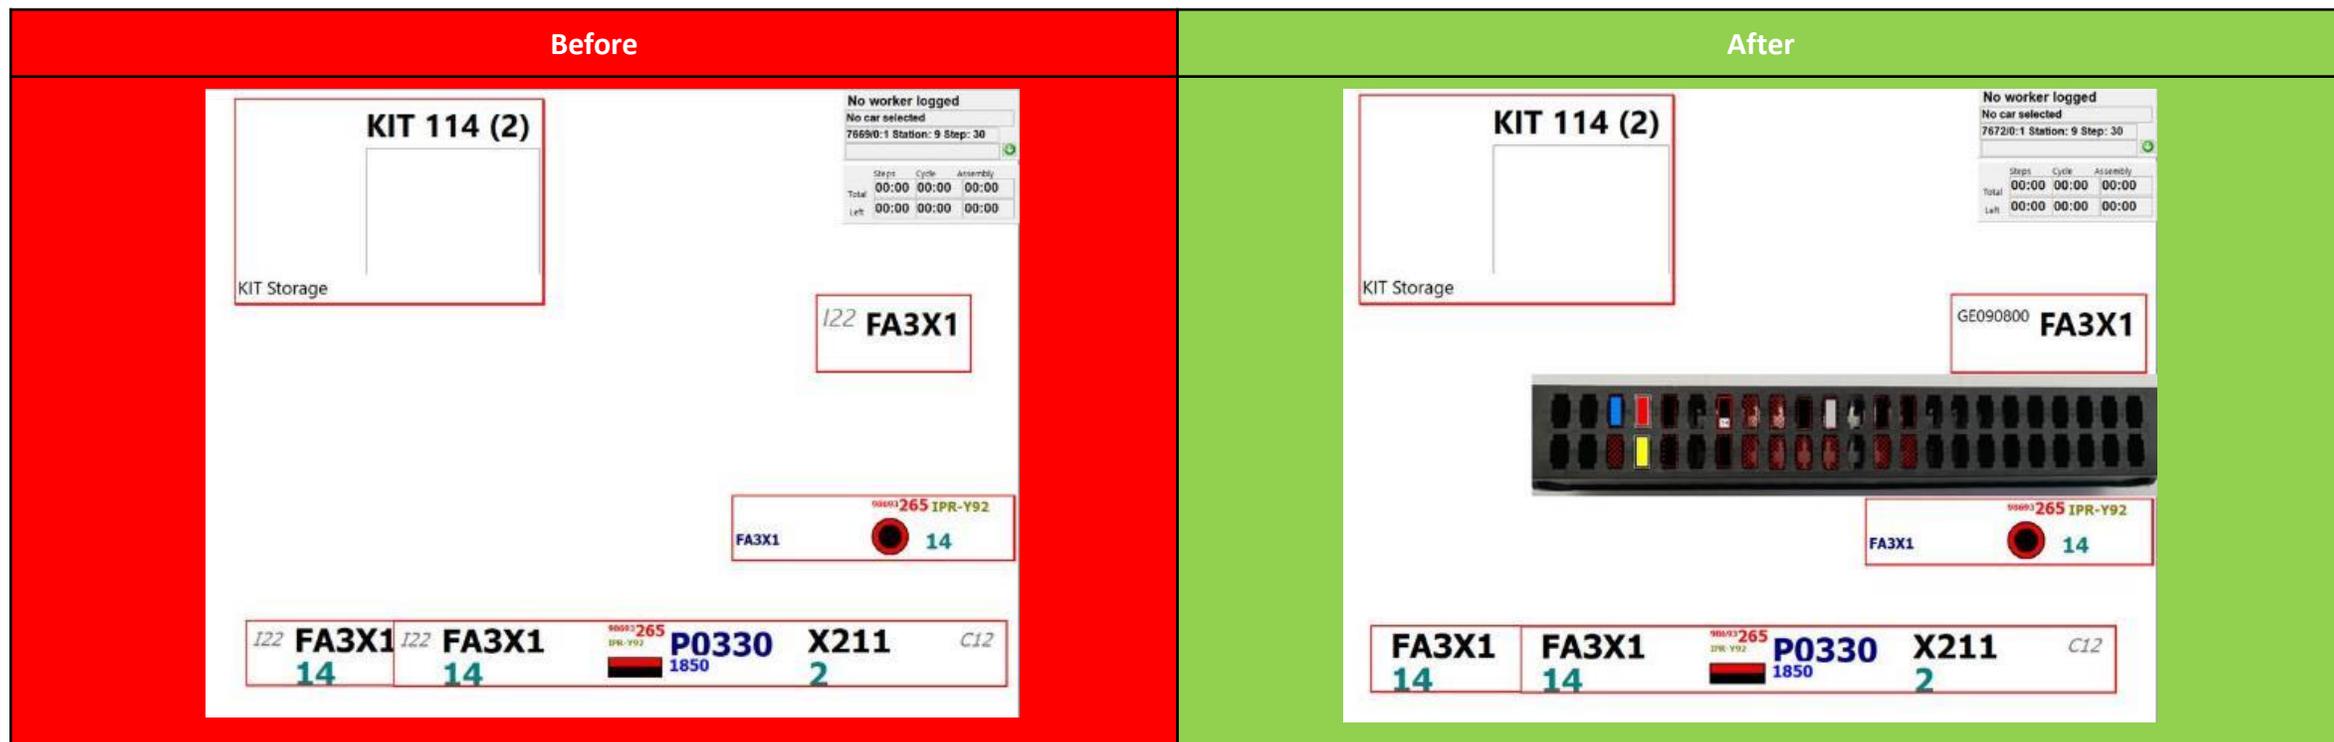
Add photo of FA3X1 in LAD

Root cause: Missing photo of FA3X1 in LAD

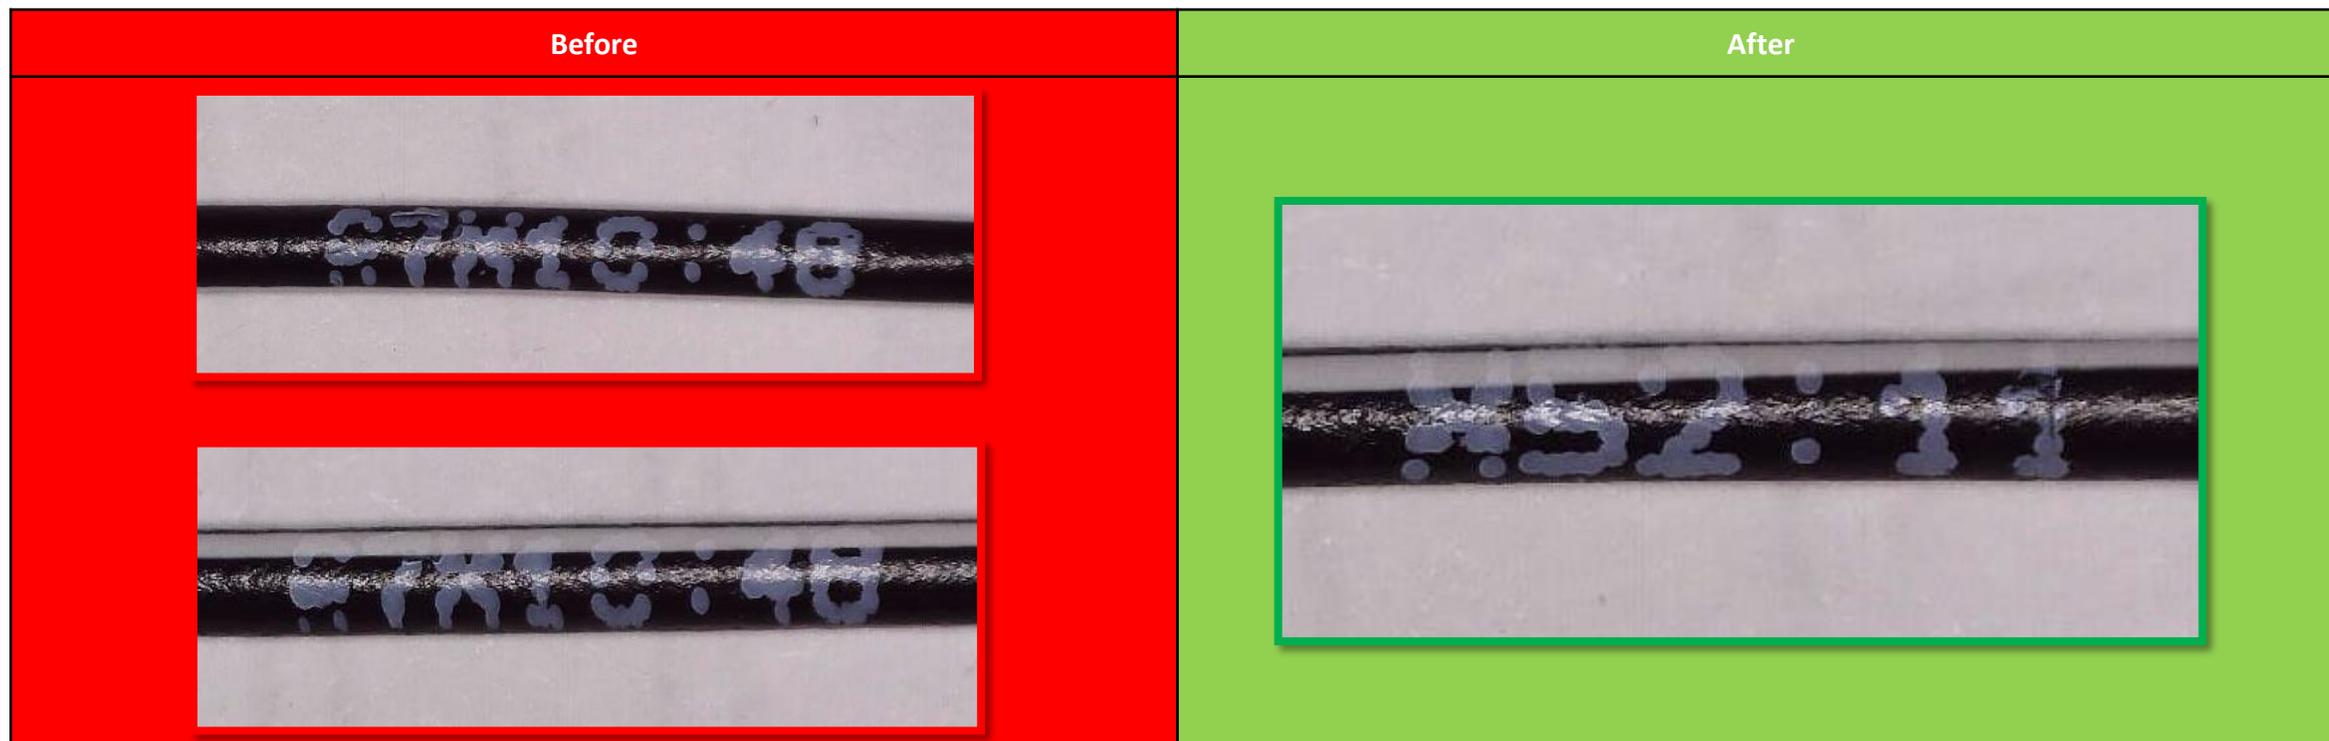
Visualization of proper print on wires

Unclear print on wires on step 1

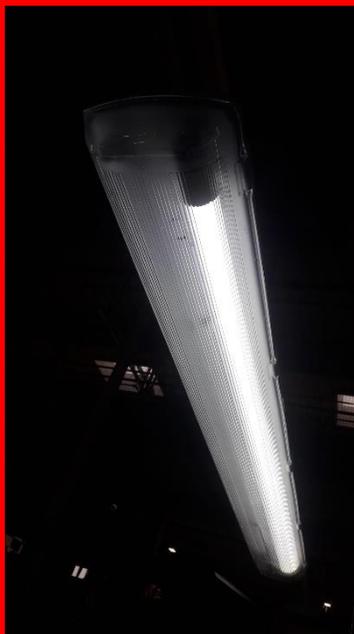
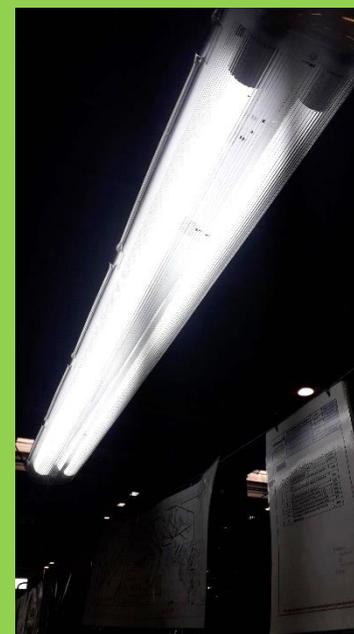
Fixing lights in assembly line

Lights on assembly stations doesn't work and reflectors doesn't work

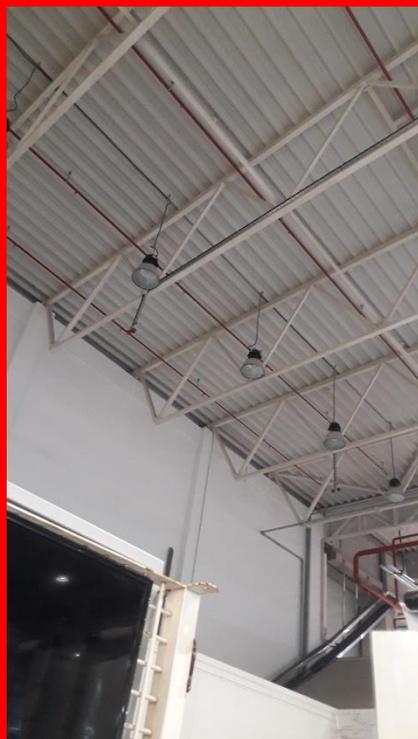
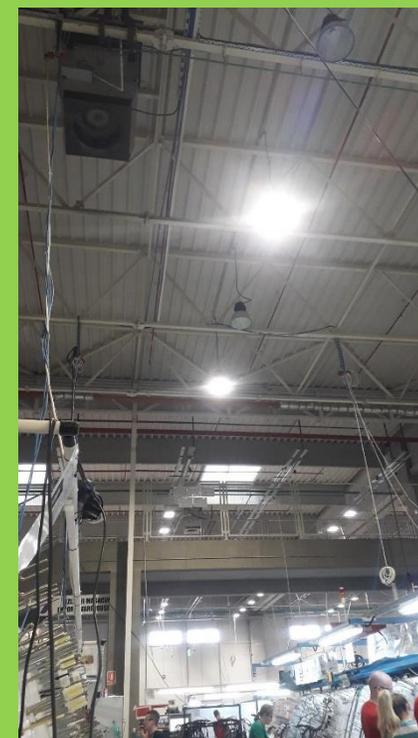
Fixing lights (reflector) above assembly line

Lights on assembly stations doesn't work and reflectors doesn't work
